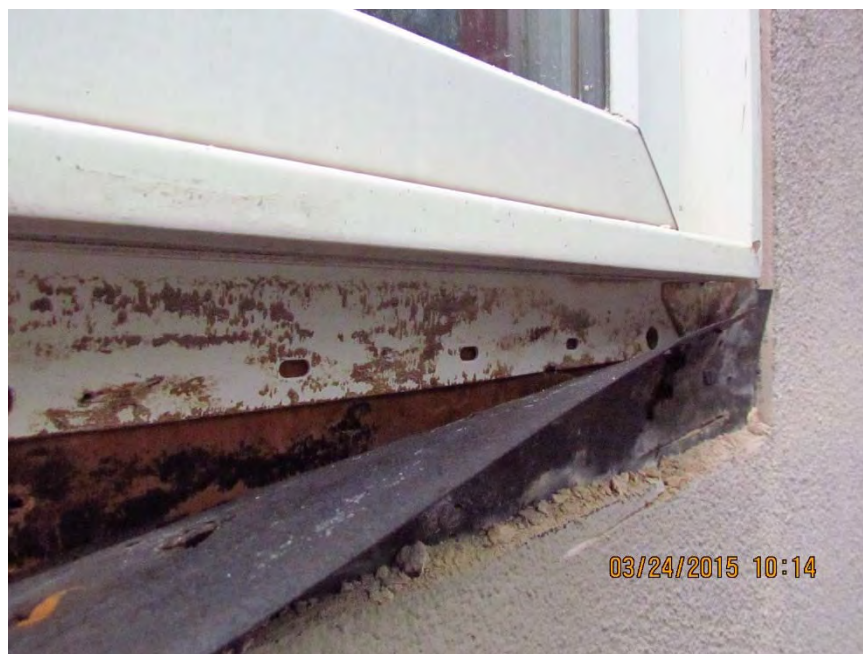
Figure 182

- g. No sealant was installed under the nailing flanges (Figures 182) or at the joint where the nailing flanges are inserted into the window frame (Figure 186) as required by the window installation instructions.<sup>162</sup> Also, no sealant was installed where required at the corner adhesive pads (Figure 186).<sup>163</sup> Further, no sealant was installed where it is required on the top outer surface of the frame at the head.<sup>164</sup>

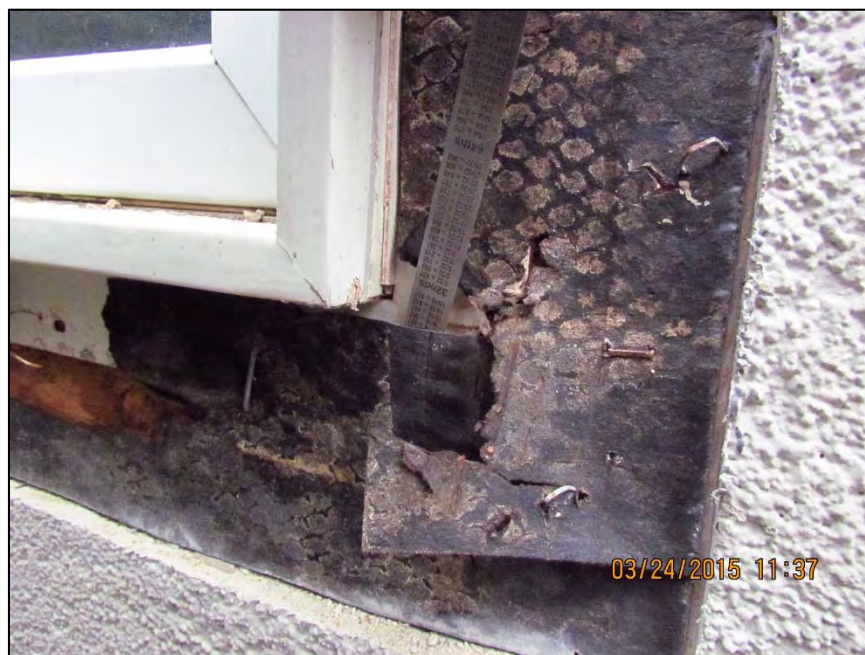
Figure 183

- e. The nailing flanges of the window frames were installed onto the wall sheathing.
  - f. The WRB is building felt. The WRB was installed over the nailing flanges at all sides of the windows (Figure 181), including the sill, creating a reverse lapped condition that can direct moisture behind the WRB (Figures 183 and 184). The sheathing below Buinewicz Specimen A was wet.

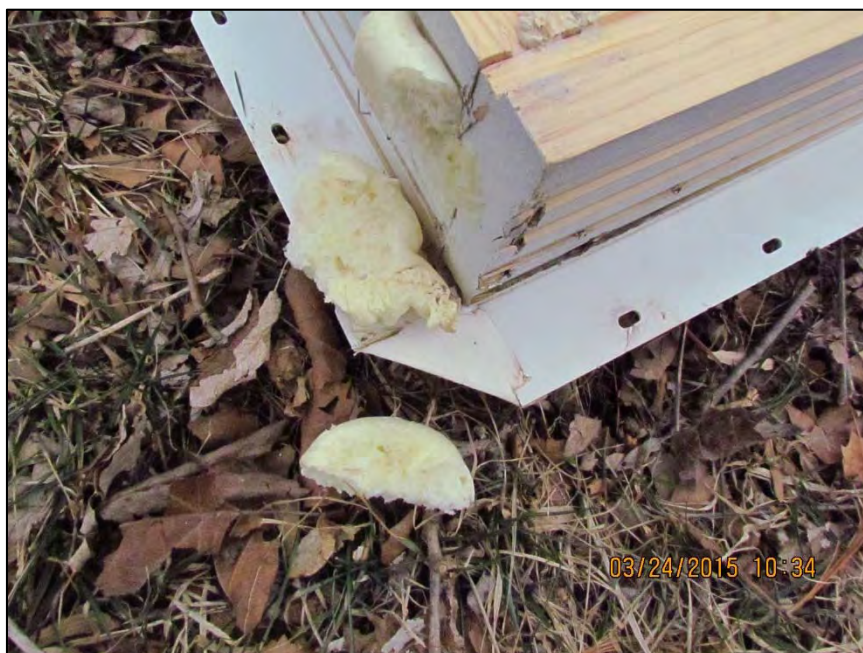
Figure 185

- c. The rough openings were not flashed prior to installation of the window (Figure 185).
  - d. No shims were used during installation of the windows.

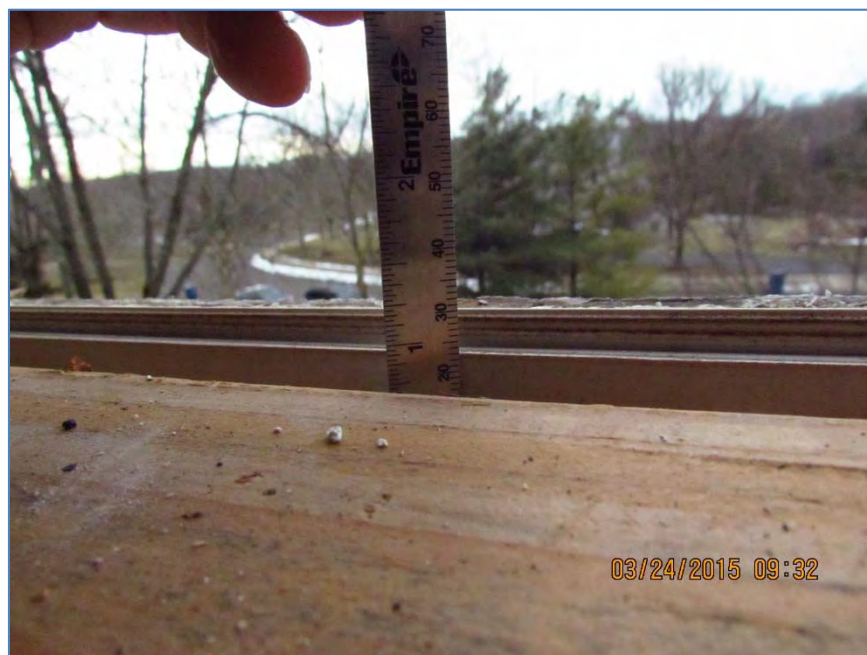
Figure 188

- a. No shims were used for installation of either of the windows (Figure 188).
- b. No WRB or flashing is wrapped into ether rough opening (Figures 188 and 191).

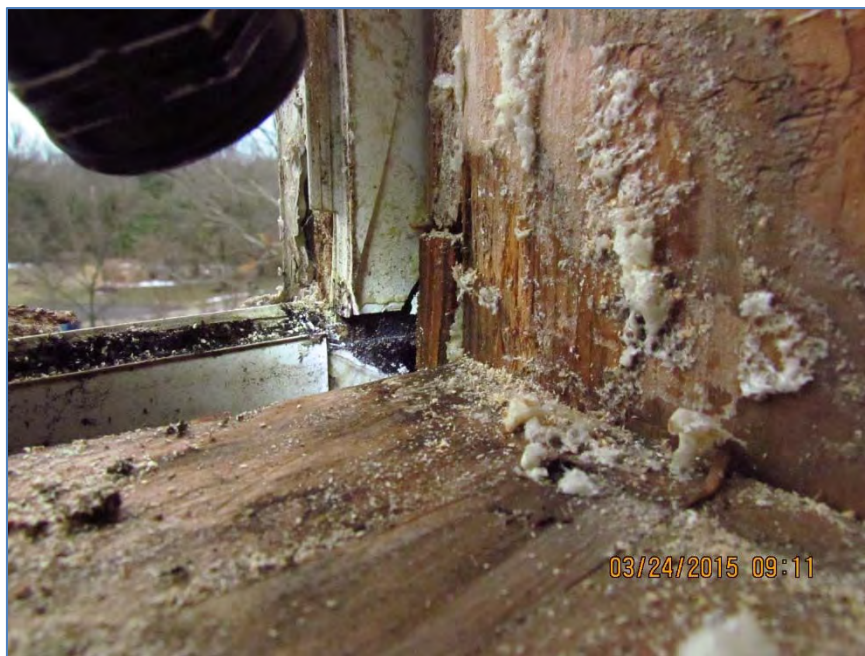
Figure 191

- c. At the twin casement window, a narrow bead of sealant was installed on the exterior perimeter (Figure 190), but the profile is very inconsistent and no backer rod was used. At the single casement window, no sealant was installed (Figure 191).

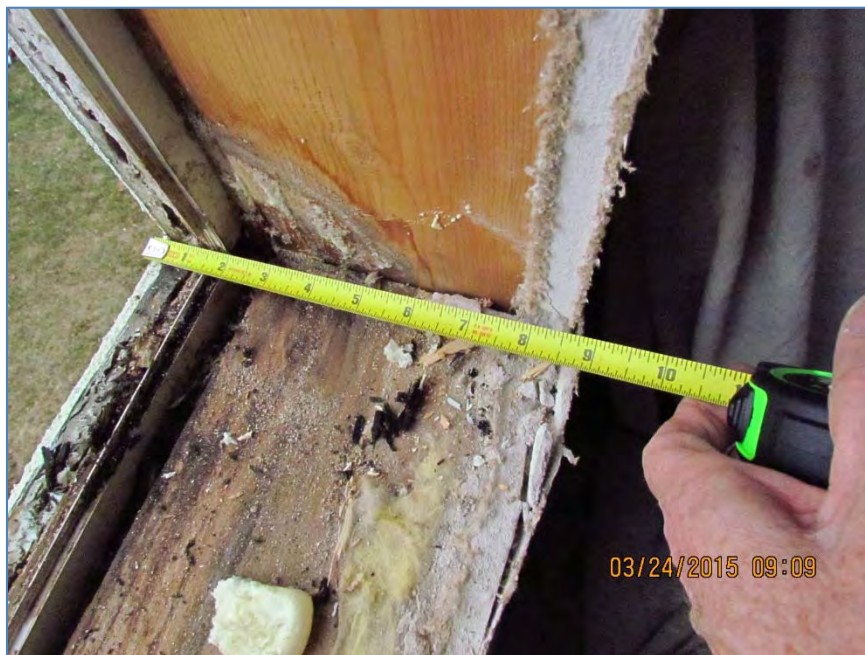
Figure 192

- e. At the twin casement window, the intersection of the nailing flanges at the bottom right corner of the window was improper; only a portion of the white corner pad is visible, and the adhesive side of flashing tape is visible at the balance of the corner (Figure 192). No sealant is visible on the inside of the corner as required by the window installation instructions.<sup>165</sup> Staining is present on the wall framing at this corner (Figure 193). Some staining is also visible at the top right corner of the opening (Figure 194).

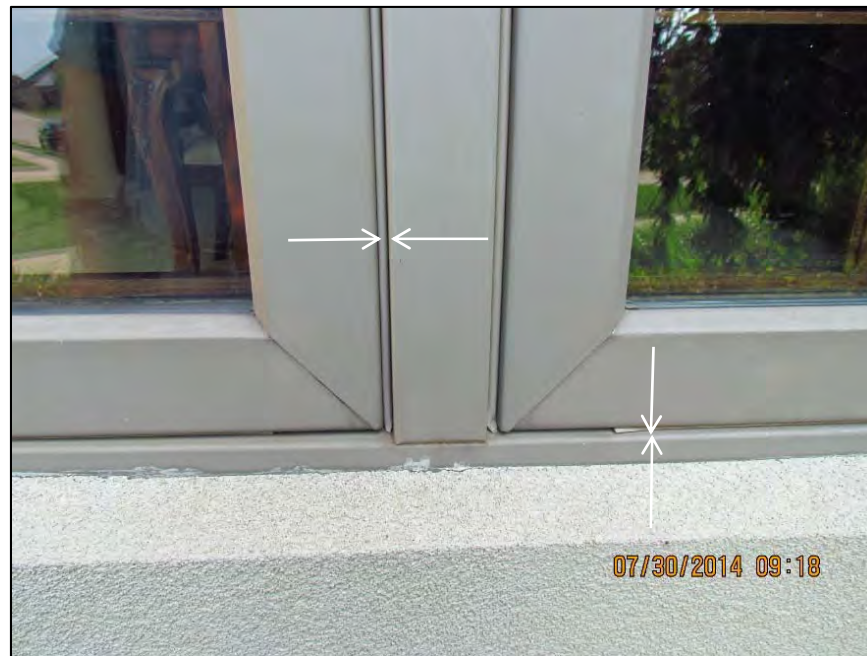
Figure 217

- a. The joints of the Kolbe window sashes and frames are tightly fitted with neat, hairline joints (Figure 217). Clearances between the sash and window frames are relatively even at the jambs but vary at the sills (Figures 217 and 218). A drip cap is installed above the windows (Figure 219).
- b. A raised synthetic stucco trim band on the exterior surrounds the typical window on the front elevation (e.g. Figure 216). Synthetic stucco trim bands are described in paragraph 8.3.5.b above. At the Deller home, the EIFS trim band is generally installed

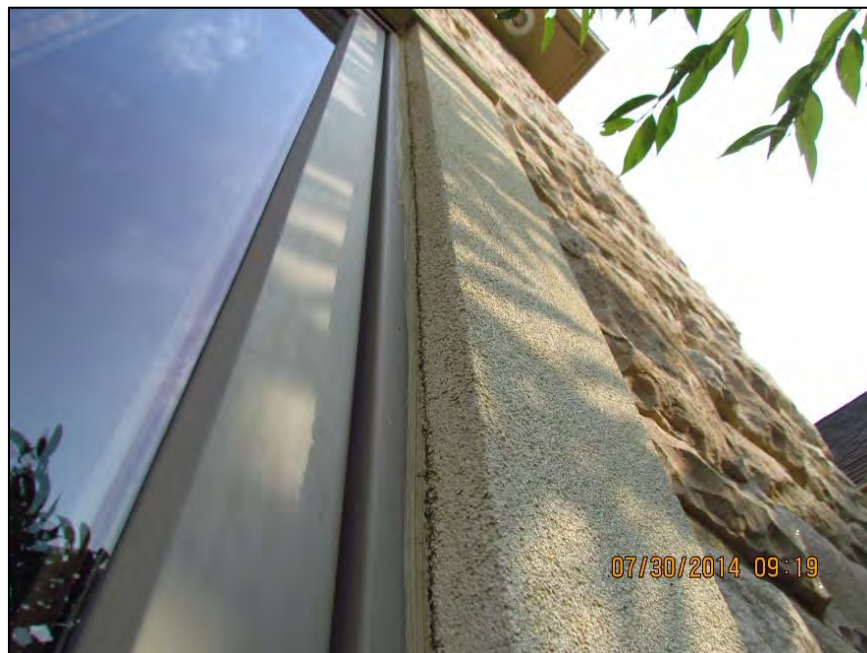
Figure 221

- tightly to the edge of the window and no gap was provided between the side of the window frame and the EIFS for sealant as required by the Kolbe installation instructions<sup>166</sup> (Figures 220 and 221). Instead, only a small thin sealant bead was applied over the surface of the joint (e.g. Figures 221 and 222), but the most vulnerable location, the sill, is generally unsealed (Figures 220 and 222). Some of the sealant has failed (Figures 221, and 223).

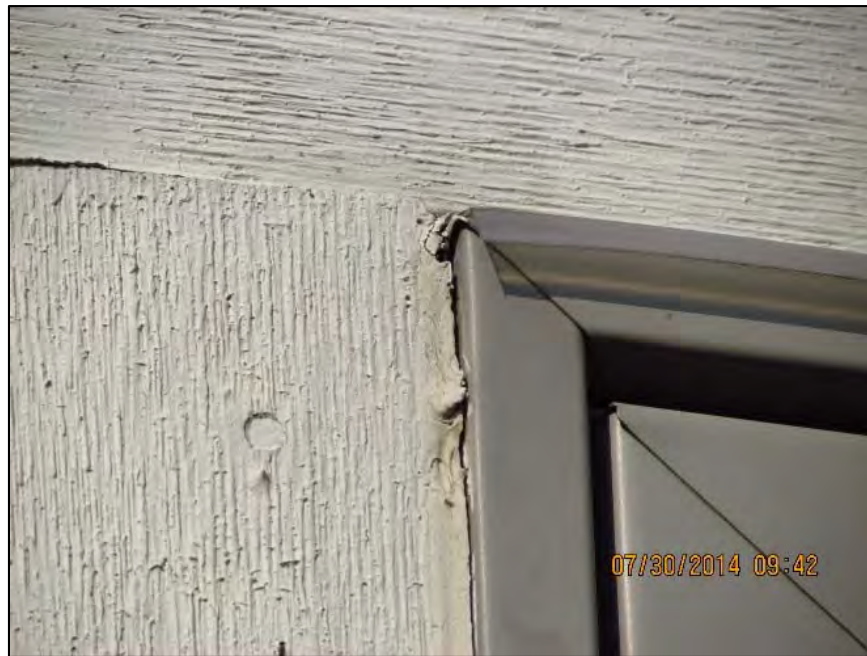
Figure 226

- c. At windows and doors installed in walls clad with cement fiber board lap siding, a trim board is installed around the window openings (e.g. Figures 224 and 225). Similar to the windows on the front elevation, the trim boards are installed tightly to the window and door frames without a sufficient gap for the installation of sealant and backer rod as required (Figure 224). In addition, the trim boards tightly adjoin each other and it appears that no sealant is installed between them. As a result, any sealant that is installed around the windows and doors, or in joints between the boards, is not able to accommodate movement of the joint. Some of the sealant has failed, and this may allow water to enter (Figures 226 and 227).

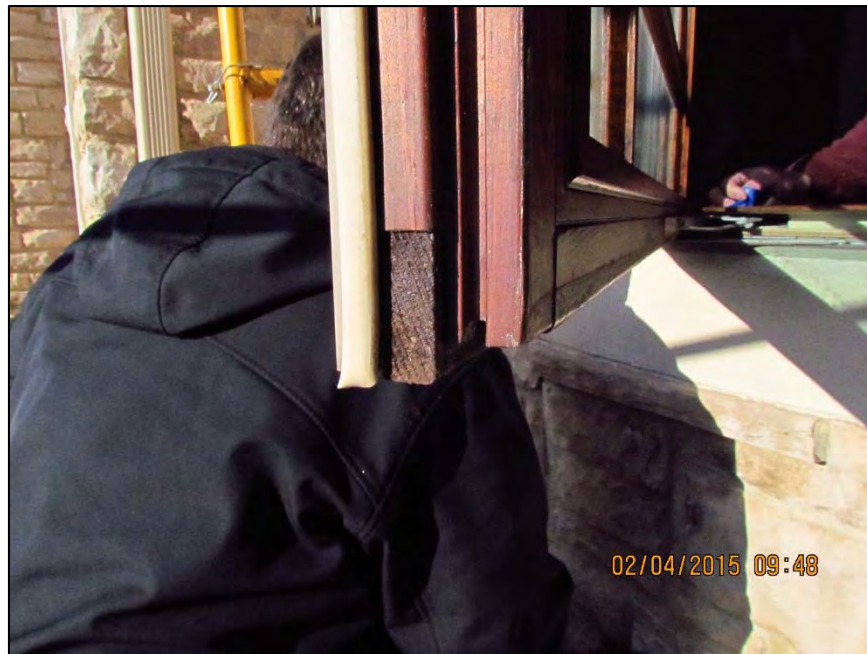
Figure 230

- d. There is no visible water staining or material degradation on the building interior and except as noted below, the wood along the edges of the window sashes typically have no visible evidence of staining or degradation (e.g. Figure 228). The window frame gaskets appear good with no breaks (e.g. Figure 229), and the sash gaskets appear to be in good condition with standard air gaps at the corners. Edges of the sash have been finished, but it appears that the end grain of the stiles was not sealed prior to application of the stain (Figure 230).

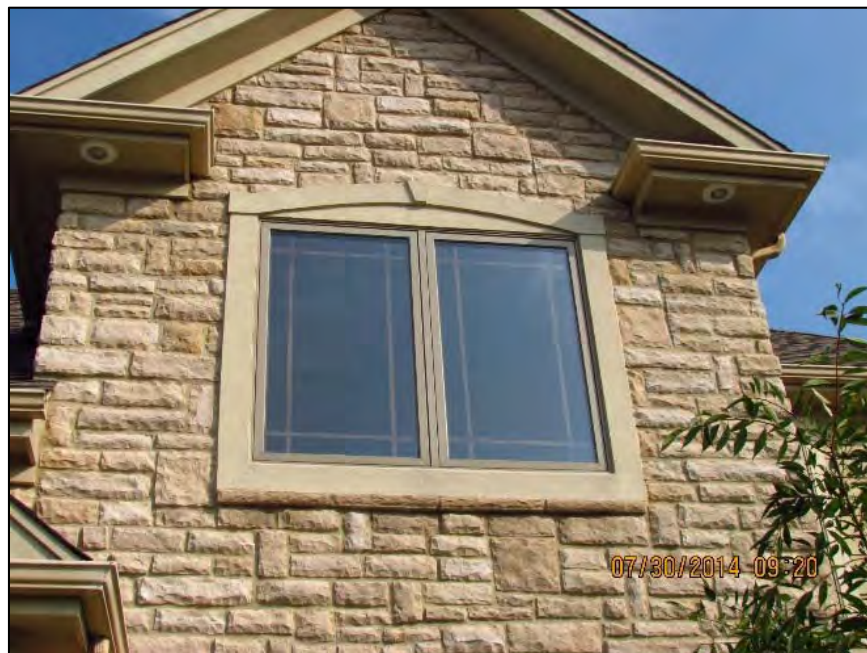
Figure 231

- e. At one window in a bedroom on the front elevation of the second floor (Figure 231), the bottom of one of the sashes had an elevated moisture reading at the time of the inspection and the sash-to-frame reveals at the top and bottom of the window sash are uneven (Figures 232 and 233). The exterior perimeter sealant on that side of the window has failed (Figure 232) and the head drip above the window is bent upward so

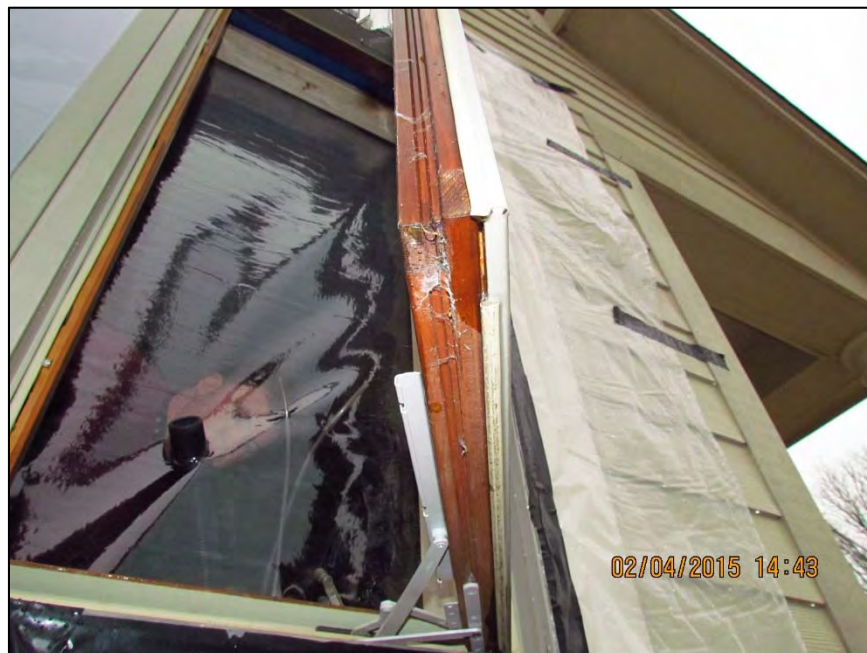
Figure 247

to 2 mm deep (Figure 247). Almost no water was on the underside of the sash although discoloration at the end grain revealed that the finish does not adequately protect the wood (Figure 248).

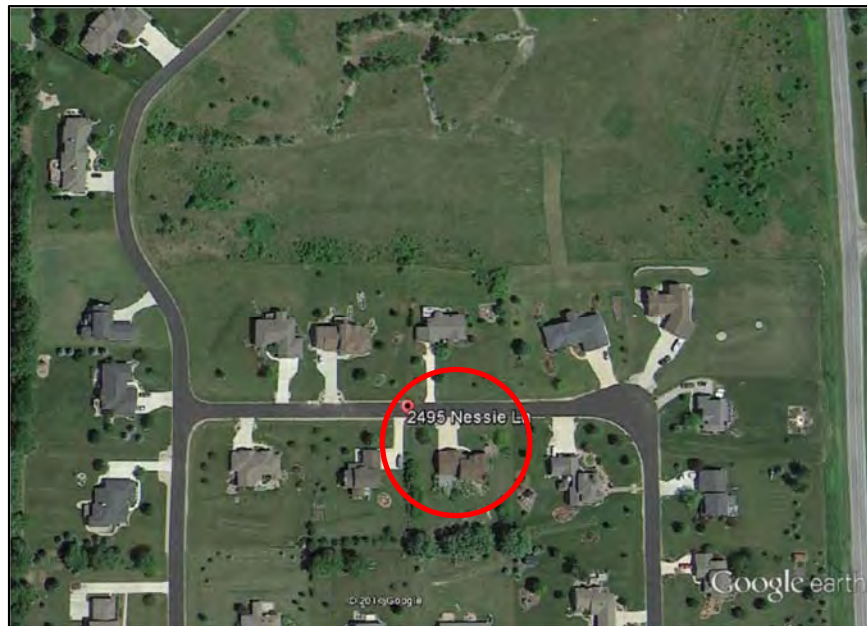
Figure 249

- 8.5.2 The Lohr residence is a two-story single family home over a basement. A covered entry faces the street on the north elevation (Figure 249). The home is located just south of an open area (Figure 250). Neighboring homes are located on either side. The home is constructed with wood framed walls. The roofing is asphalt shingles and has some gutters and downspouts. Conventional roof overhangs offer some protection to openings immediately below the roof line but far less to those on the lower levels, and the gable end walls on the east and west elevations provide very little protection to openings on those walls. The exterior wall cladding is primarily vinyl lap siding on the north (Figure 249), west (Figure 251), south (Figure 250), and east (Figure 253) elevations. There are also small areas of brick cladding on the north elevation (Figure 249).

8.5.4 On October 2, 2014, Exponent removed a window on the front elevation for examination (Arrow at Figure 249). This is an operable casement window, but because of its location in a stairwell, the window is only accessible from the interior by use of an extension ladder. The window sashes are original 2000 vintage. GCI's noted the following:

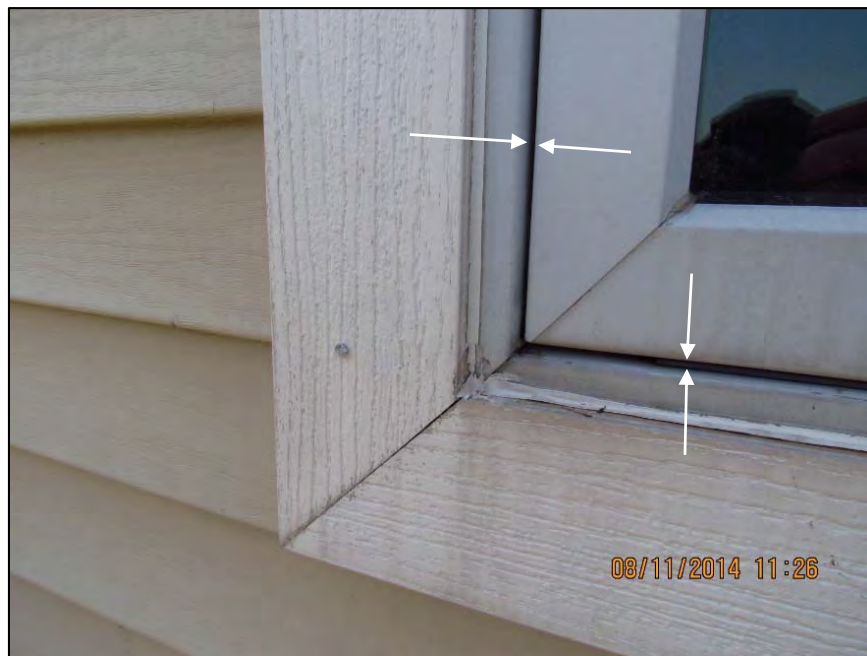
Figure 254

- a. Typically, the joints of the Kolbe window sashes and frames are tightly fitted with neat, hairline joints (e.g. Figure 254). Clearances between the sash and window frames are relatively even except for some variances at the sill. A drip cap is installed above the windows, but on the north elevation, most of them have been covered with sealant (Figure 255).

- b. On the north elevation, PVC trim boards are installed around all the windows (Figures 254 and 255). The trim boards are tightly abutted to the sides of the window frames. There is no gap between the trim board and the window frame for the installation of sealant and backer rod. Instead, a very small bead of sealant has been applied over the exterior face of the window frame and the edge of the trim board, but the sealant bead is too small and improperly configured. Much of the sealant has failed (Figure 256) and this exposes the joint between the window and the trim board, which can allow water to enter. At the balance of the home, vinyl siding trim is installed around the windows (Figure 257).

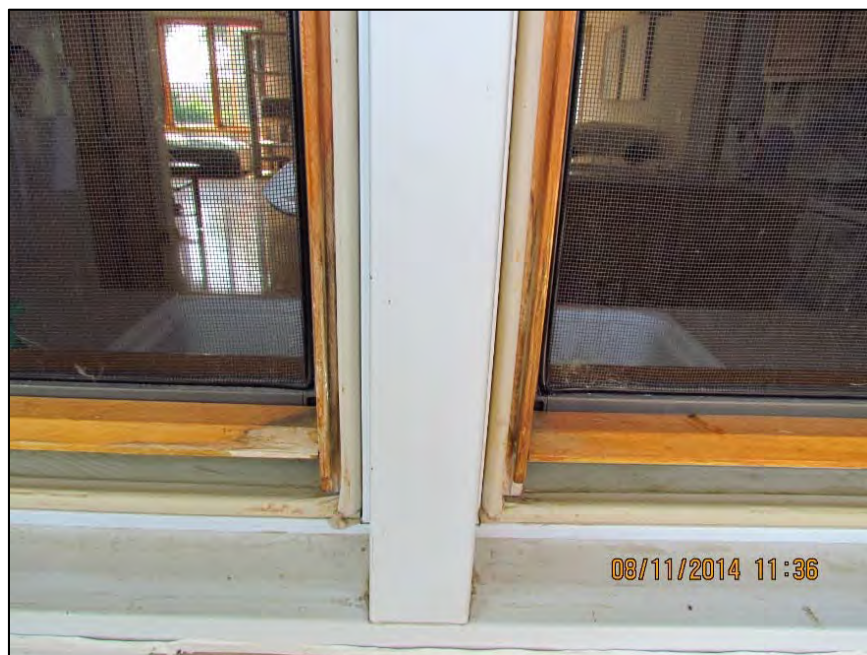
Figure 258

- c. No elevated moisture readings were found in the wood of the sashes, sash stops, extension jambs or stool trim. The frame gaskets appear good with no breaks (e.g. Figure 258), and the sash gaskets appear good and pliable with air breaks at the sash corners (Figure 259). Variations of the interior finish suggest that the field applied interior finish in some areas may only include one coat of clear finish over the stain in lieu of two coats as recommended.<sup>181</sup>

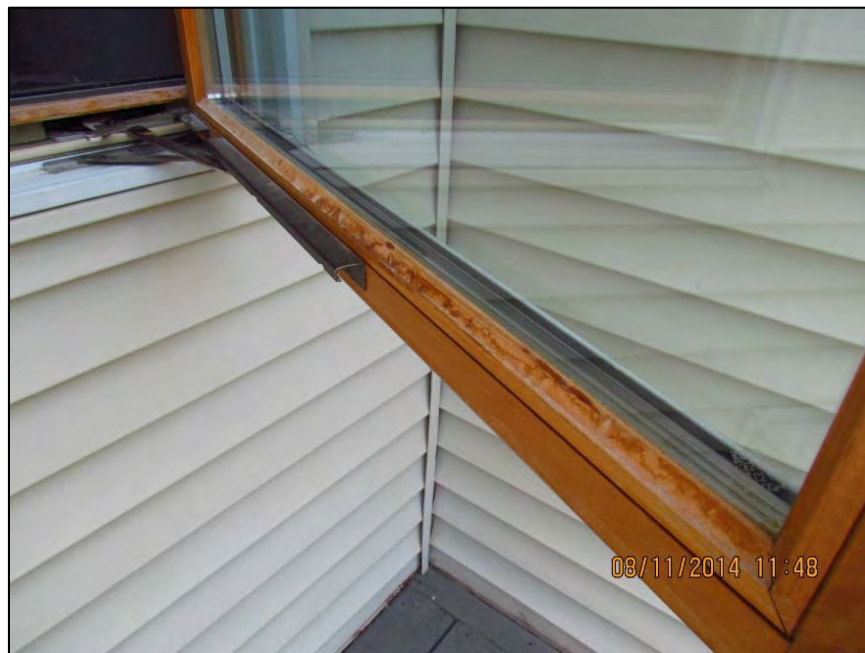
Figure 260

- d. At several windows, including many with sashes that are dated 2010, there is evidence of moisture collecting on the sash bottom rail (Figures 260) as well as on top of the sash stop on the window sill frame member (Figures 260 and 261). This type of staining commonly occurs because of condensation that forms on the interior glass surface during cold weather days and indicates the interior finish is inadequate to protect the wood.

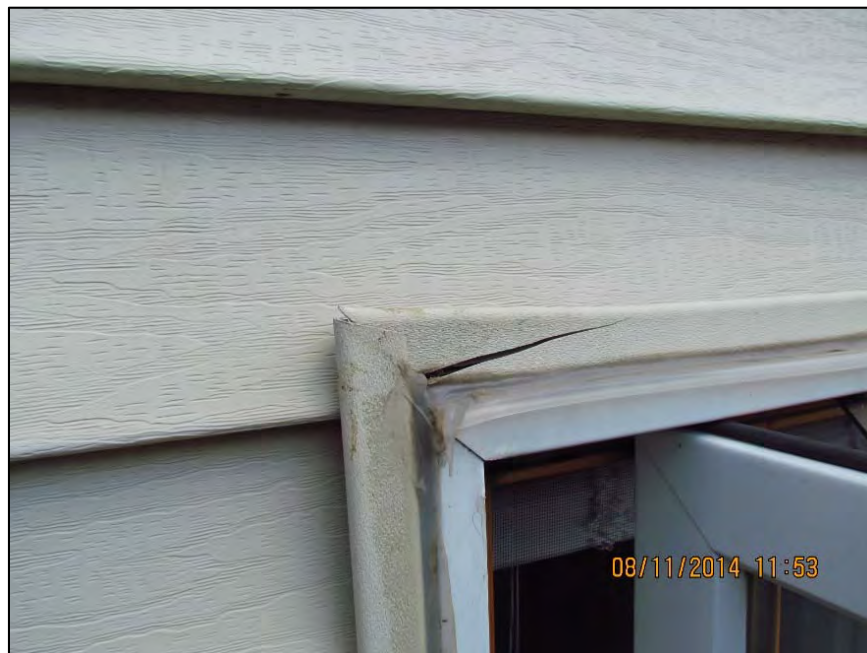
Figure 262

- e. At a window in the basement on the south elevation, sealant has been added to the vinyl siding J-trim on the exterior; this was not done elsewhere at the Lohr home which suggests that this was an attempt to address water leakage problems. The sealant workmanship is very poor (Figure 262). At the bottom of this window, there is staining on the extension trim suggesting that water enters from around the window opening (Figure 263). At grade level of this window, panels were used as facing on the exterior of the wall, and these extend below grade with unsealed 'H' bars between the panel, which are not waterproof (Figure 264). The sill of the window is close to grade level (Figure 265) although some of the other windows on the basement level are even closer to the grade.

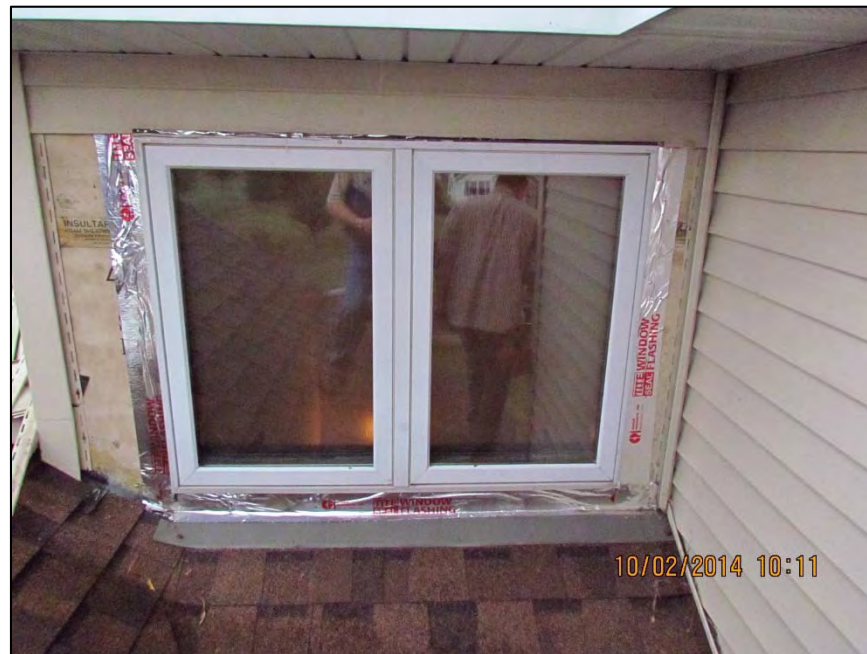
Figure 266

- a. The wall sheathing is a rigid foam board with taped joints over oriented strand board. No separate WRB was used. The window nailing is applied directly to the rigid foam board and self-adhesive flashing tape was applied over the nailing fins, onto the rigid foam board (Figure 266). Expanding foam was installed around the interior perimeter of the window, between the window frame and the wall framing.
- b. The window frame was installed approximately ¼" out of square. No shims were used to set the window. The Kolbe installation instructions require that sealant is to be applied to the inward side of the nailing flange where the flange is inserted into the wood window frame.<sup>182</sup> The sealant was not installed (Figure 267).

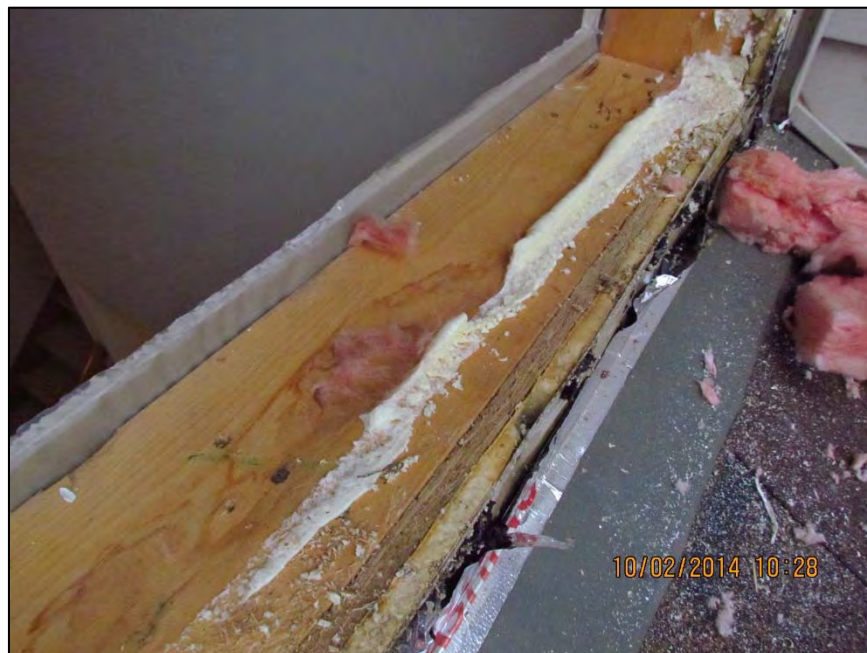
Figure 268

- c. There is very slight discoloration on the rough opening sill (Figure 268). However, the sill of the rough opening had not been flashed. Also, there is no indication of water leakage through the window frame thus indicating that if the discoloration occurred after window was installed, it entered around the perimeter of the opening, not through the window frame joinery.
- c.. There is condensation staining on the lower portions of the two sashes and also on the sill stop that is attached to the window frame (Figures 269 and 270). There is no evidence of water leakage through the window frame.

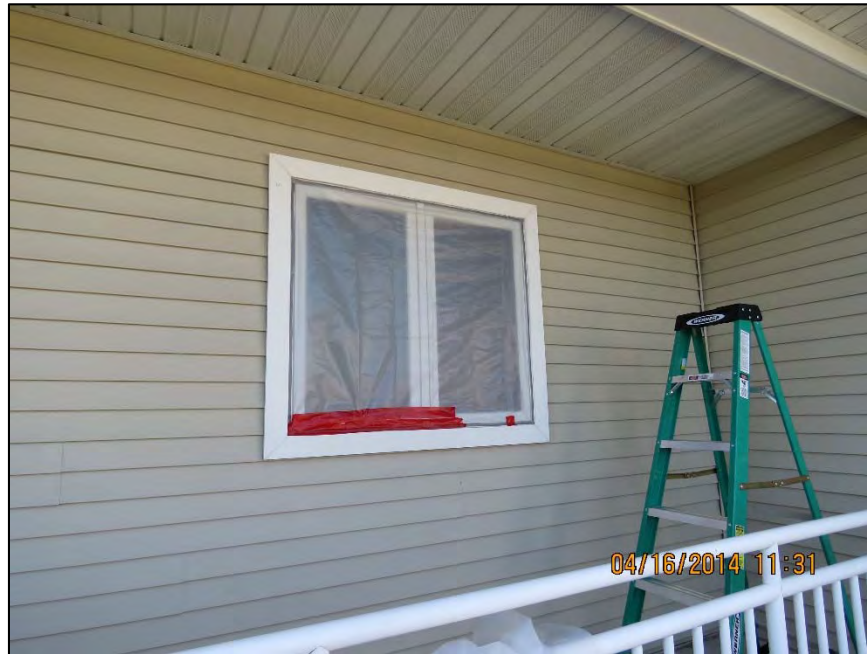
Figure 271

- a. The window selected by Exponent is located on the first floor in the kitchen on the north elevation (Figure 271). For the purposes of this report, the window identified as Lohr Specimen A. The window is located on a covered porch and would not be regularly exposed to rainfall. Prior to testing, examination revealed that some water stains on the portions of the window sashes and on the sill sash stop consistent with that caused by condensation (Figures 272 and 273).

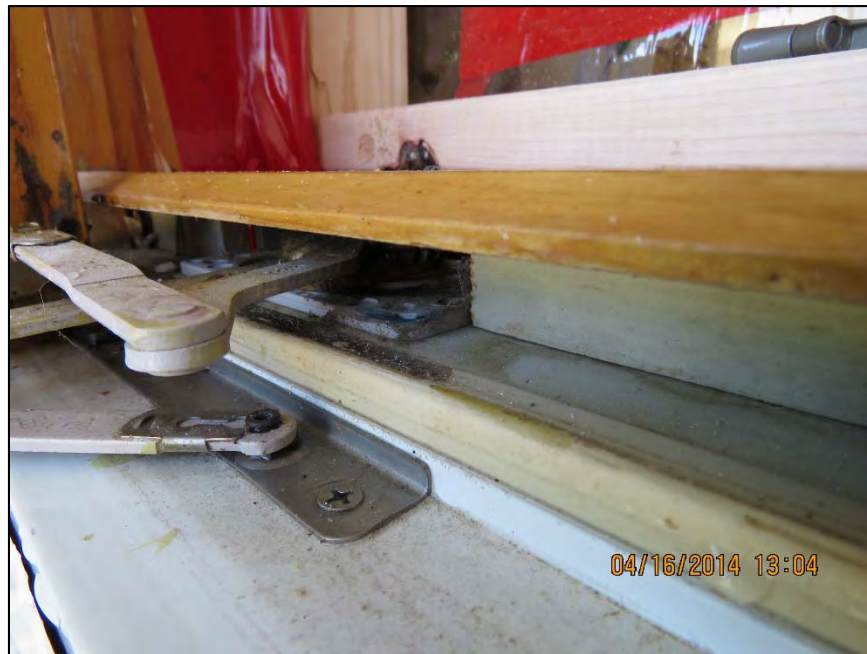
Figure 275

to 2 mm deep, and almost no water was on the underside of the sash (Figures 275 and 276).

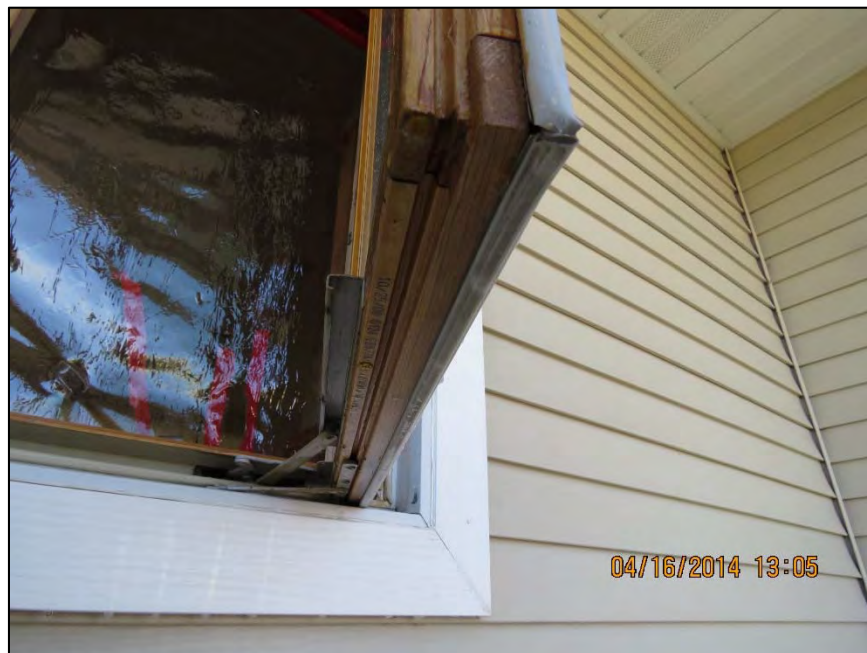
Figure 276

- g. There are no leakage stains or deterioration of the window framing or sash (Figures 276 and 282).

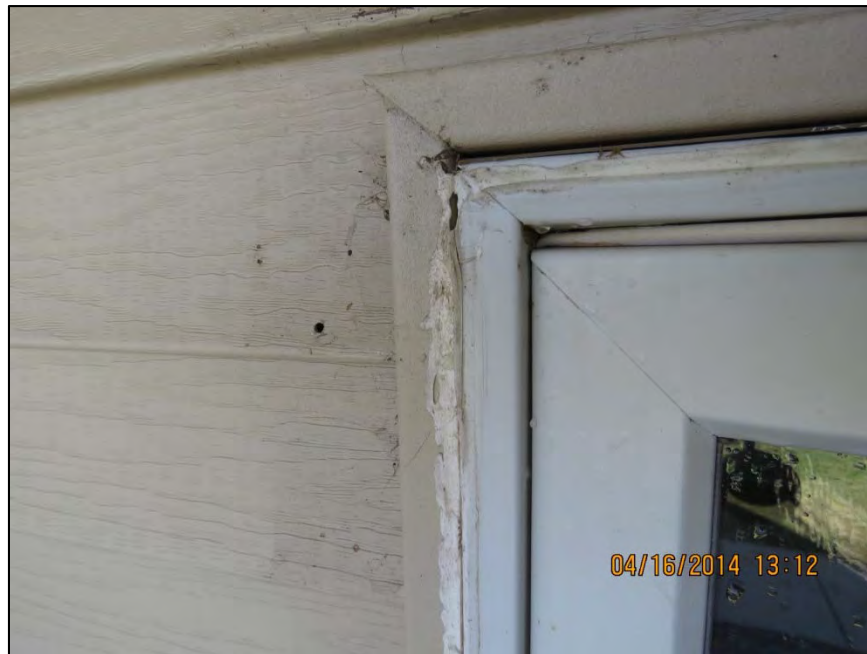
Figure 277

- a. The exterior perimeter of the window was face sealed to the PVC casing trim, including at the head. Thus, the sealant was applied over the face of the head flashing (Figure 277). Much of the sealant had failed.

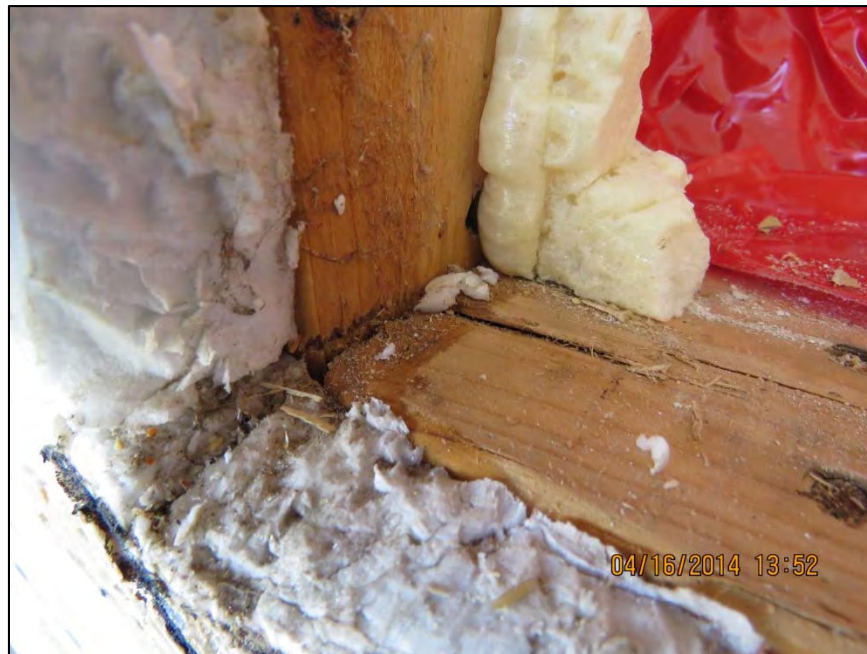
Figure 281

- d. No rough opening flashing was provided (Figure 281).
- e. No shims were used to square the window frame during installation.
- f. There is a slight amount of moisture at the bottom left corner of the window opening that appears to have occurred during the water testing that was done immediately prior to removal of the window (Figure 281). This was not visible during the test and there is no indication of prior moisture entry at this point; it would appear that the leak was induced by the test procedure and not representative of any prior leakage. The moisture originates at the exterior face of the sheathing, indicating that moisture entered around the perimeter of the window, under the nailing flange.

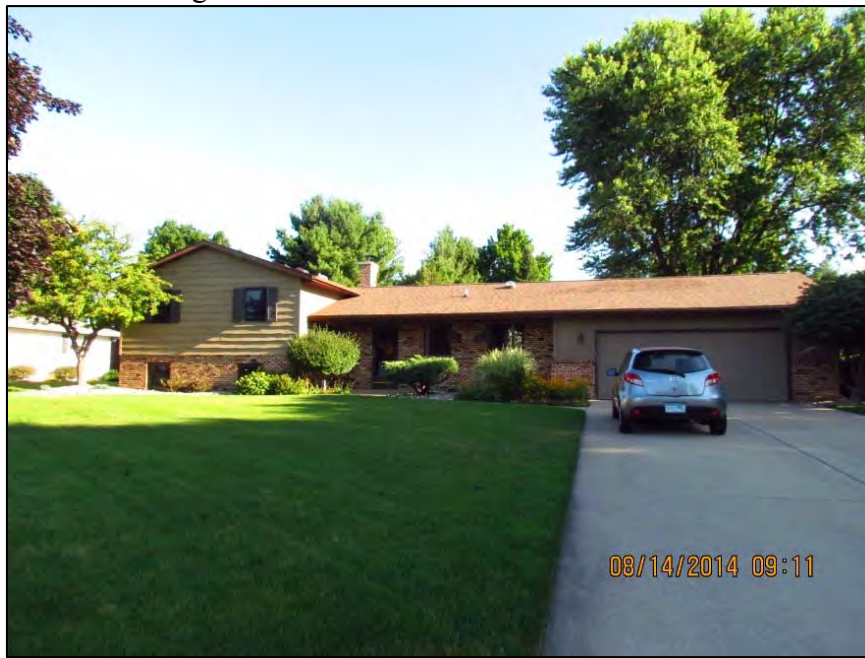
Figure 283

- 8.6.2 The McIver residence is a split level, single family home. A covered entry faces the street on the south elevation (Figure 283). The home is in an urban setting; the east (Figure 284), west (Figure 285) and north elevations (Figure 286) face adjacent residential properties. The roofing is asphalt shingles with some gutters and downspouts. Conventional roof overhangs provide some protection to window openings immediately below the roof on the west elevation and at the covered entry on the south. The roof overhangs provide little protection to windows in the gable end walls or to windows on the basement level. The exterior walls are wood frame construction. The exterior wall cladding at the two story portion of the home is brick on the basement level and rough cut wood horizontal lap siding at the second floor. At the first floor level, the exterior wall cladding includes both brick and Texture 111 siding.

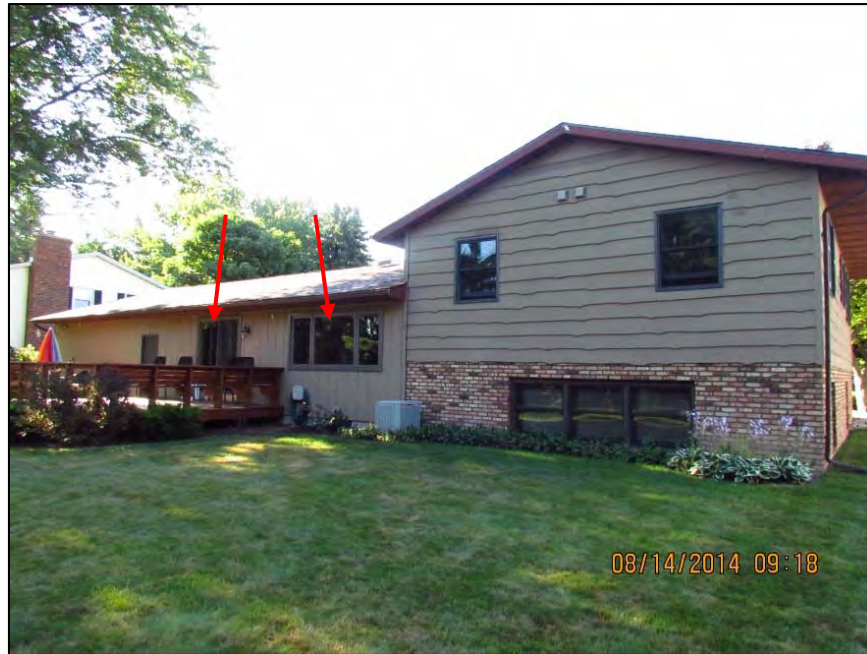
Figure 286

8.6.3 In addition to the Kolbe products discussed herein, there is also a window opening and a sliding patio door on the north elevation that are not Kolbe products (arrows at Figure 286).

- g. No elevated moisture readings were found in the wood of the sash, sash stops, extension jambs or stool trim, however, elevated moisture readings were found in the sill of the center window of a triple unit located in the basement on the north elevation (Figure 286) indicating that moisture is collecting under the frame sill (Figure 305). As previously noted, the sills of the windows on the lower level are located at, or nearly at, grade level and also, the sealant applied here has failed and the window frames are set directly onto the brick which absorbs moisture. Of note, there are seven windows on the basement level and the owner has marked eight windows in the home with alleged problems, seven of which are basement windows. The one window on the second floor that was marked by the owner may have been marked because of blistering paint on the sill (Figure 306). The sealant at this window has failed (Figures 307 and 308). In addition, installation conditions at this window appear no different than those uncovered upon removal of McIver Specimen B, and as explained below, evidence indicates that sealant and flashing defects allow water to enter around the window, and this has caused damage to the window.

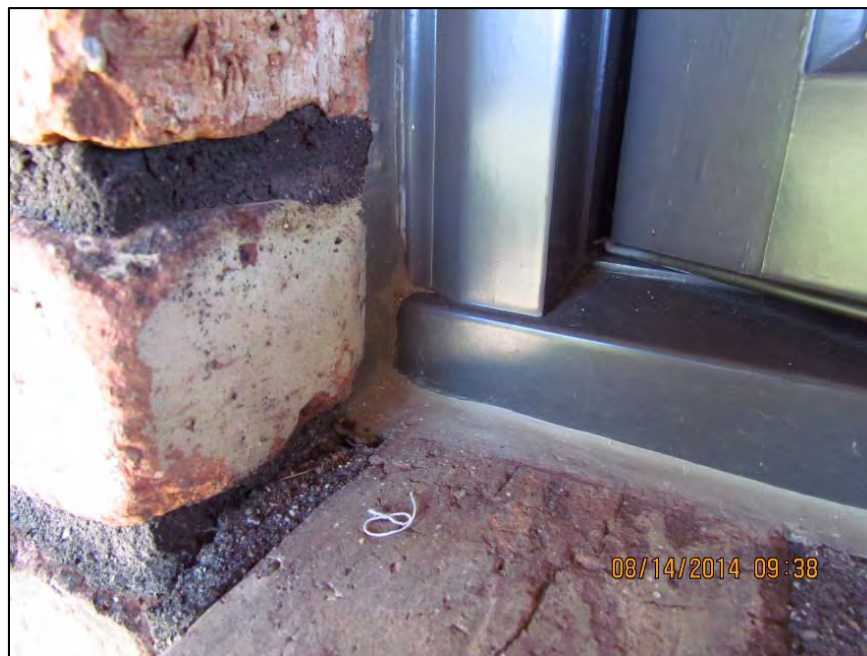
Figure 287

- a. Wood-to-wood joints of the Kolbe window sashes and frames are typically tightly fitted with neat, hairline joints (Figures 287, 288, and 289). Window frame gaskets appear good with no breaks and sash gaskets appear good and pliable. The owner/contractor applied interior painted finish does not extend to the edges of the sashes at the casement

- d. At brick clad walls, there is no gap between the jamb brickmould trim and the brick for the installation of sealant and backer rod as recommended by the Kolbe installation instructions<sup>194, 195</sup> and by the BIA<sup>196</sup> (Figures 287 and 293). Instead, sealant is installed over the face of the brickmould and onto the brick, but workmanship in some areas is very poor (Figures 293 and 294). Much of the sealant has failed (Figures 294, 296 and 297). At the head, a wood filler strip is installed. It appears that the filler strip is installed over the substrate materials, but no sealant was used between the filler strip and the brickmould or between the filler strip and the steel lintel above (Figure 295), and as noted previously, no head drip cap is present. Without the appropriate sealant, water and air can infiltrate inward of the window framing.

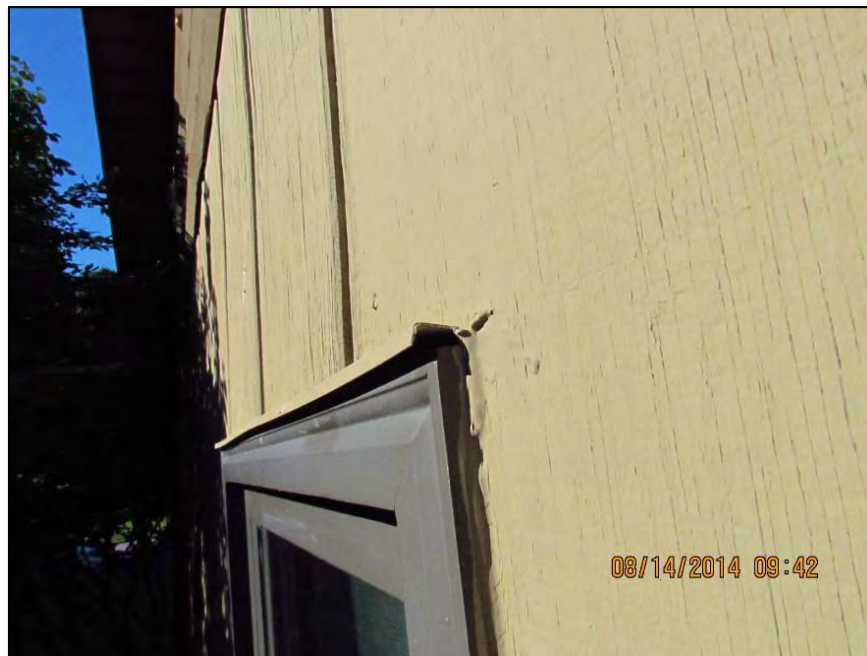
Figure 288

- b. A drip cap is installed above the windows in walls with lap siding and with Texture 111 siding, but some of the drip caps have a reverse slope back towards the siding (Figures 288 and 292). No drip cap is installed in the brick walls (Figure 289).

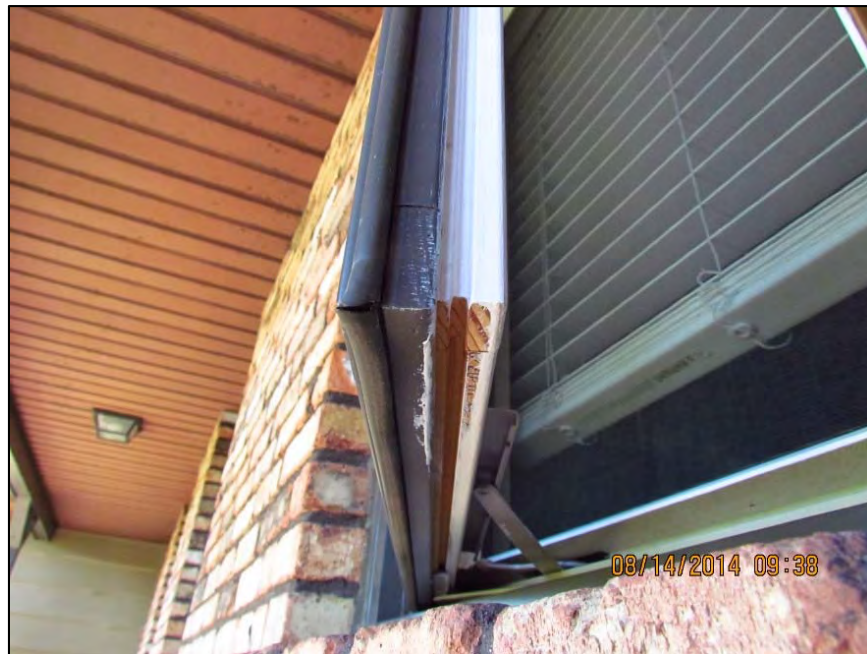
Figure 290

window (Figure 290).

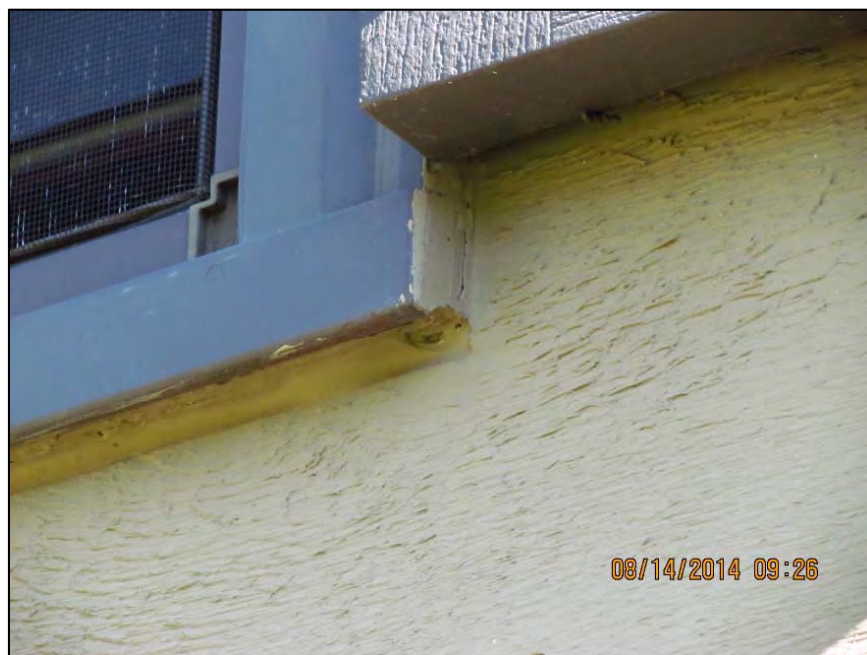
Figure 291

- c. The rough cut lap siding at the second floor level was cut to fit around the windows. In some cases, a gap with sealant can be seen between the window and the siding (below window sill at Figure 291), but in most cases the siding tightly abuts the window leaving no gap for the installation of sealant and backer rod as is required by the Kolbe installation instructions.<sup>193</sup> Instead, a bead of sealant was applied over the surface of the siding and onto side of the brickmould trim. The size of the sealant bead is too small and poorly configured. Much of the sealant has failed, which can allow water to enter (Figure 292).

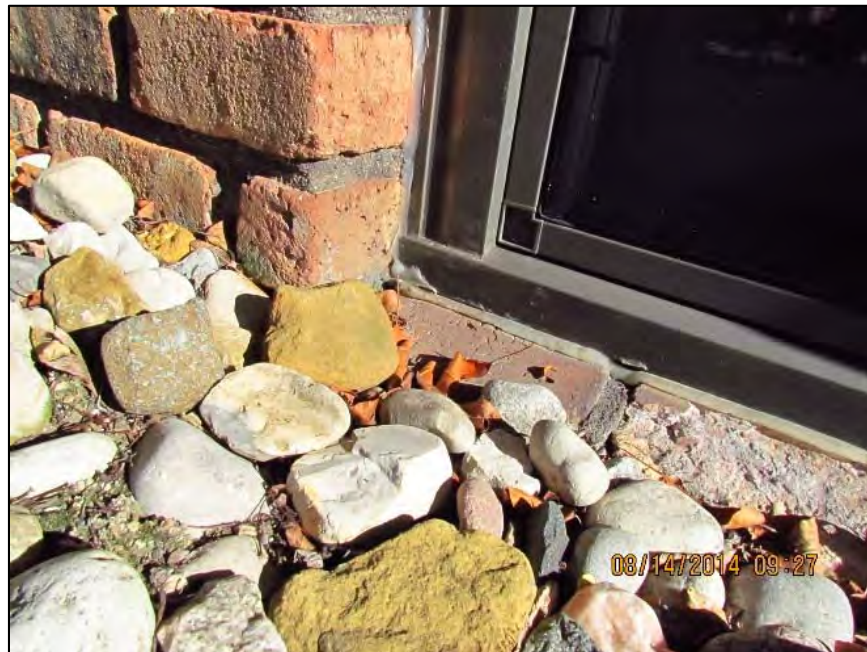
Figure 293

- e. The sills of the windows on the basement level are at or near grade level (Figure 293, 294, and 296), and on the front elevation, the grade slopes towards the window sills
